CONVERTING A SWING PAN TO IRS

The crew at Ron Lummus Racing shows us how it's done

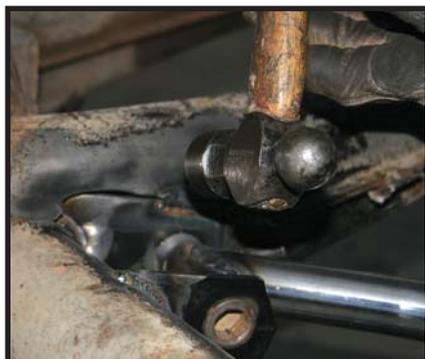
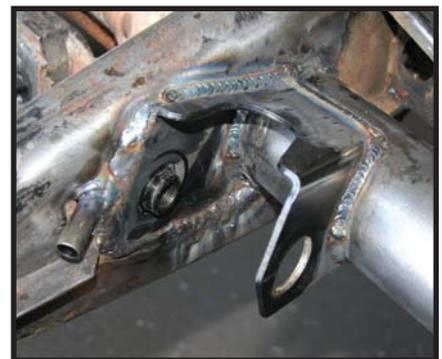
horn without removing excess material. To help determine where material needed to be removed, he would check the alignment of the jog plate against the torsion housing to see if he needed to go up, down, forward, or back. It was also necessary to remove material from the new brackets themselves, in order to get everything to properly fit. Also, the brackets sit very close to the emergency brake tubes, and when working close to those tubes Ron traded the plasma cutter for various other grinders and cut-off wheels to prevent damage to the tube.
